## Overview - Ecological Risk Assessment (ERA) Process

# Q Creek Slope Area Changes

# Q Creek Slope

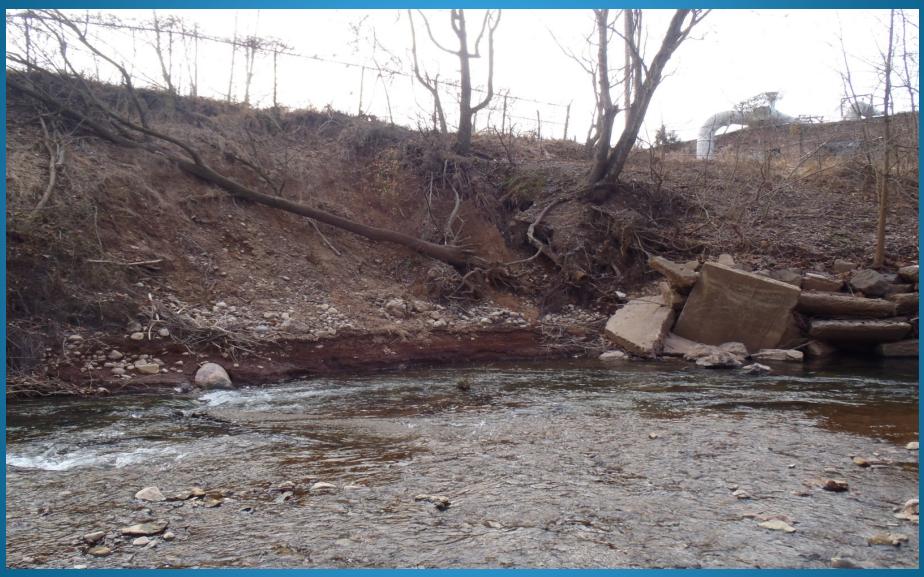
- Steep slope along southern bank of Q Creek in Coatings Facility Area (CFA)
- Following major storm events of 2011, slope instability observed
- SAM implemented 5/2012 4/2013 to stabilize bank
  - PCB-impacted soil removed
- Post-SAM data considered in BERA
